INDOOR AIR QUALITY ASSESSMENT

**Lincoln Elementary School
76 Lincoln Street
Northborough, Massachusetts**

Prepared by:
Massachusetts Department of Public Health
Bureau of Environmental Health Assessment
January 2001

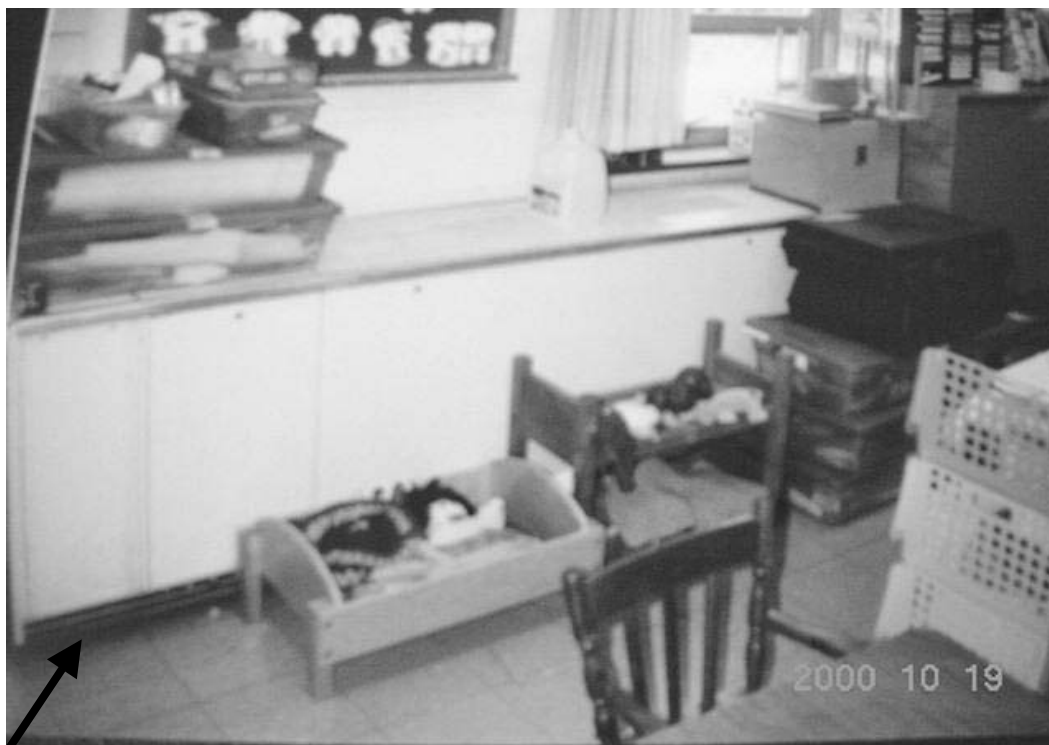
Picture 1

Fresh air in classrooms is supplied by a unit ventilator (univent) system (see Picture 1). Univents draw air from outdoors through a fresh air intake located on the exterior walls of the building (see Picture 2) and return air through an air intake located at

Obstructions to airflow such as books, papers and other items on top of univents, and bookcases, tables and file cabinets in front of univent return vents, were seen in a number of classrooms. To function as designed, univent air diffusers and return vents must remain free of obstructions. More importantly, the units must be activated and allowed to operate while the building is occupied.

Classroom Univent Note Materials Obstructing Return Vent along Bottom

5. Remove all blockages from univent fresh air diffusers and return vents to facilitate airflow.
6. For buildings in New England, periods of low relative humidity during the winter are often unavoidable. Therefore, scrupulous cleaning practices should be adopted to minimize common indoor air contaminants whose irritant effects can be enhanced when the relative humidity is low. To control for dusts, a HEPA filter equipped vacuum cleaner in conjunction with wet wiping of all non-porous surfaces is recommended. Drinking water during the day can help ease some symptoms associated with a dry environment (throat and sinus irritations).

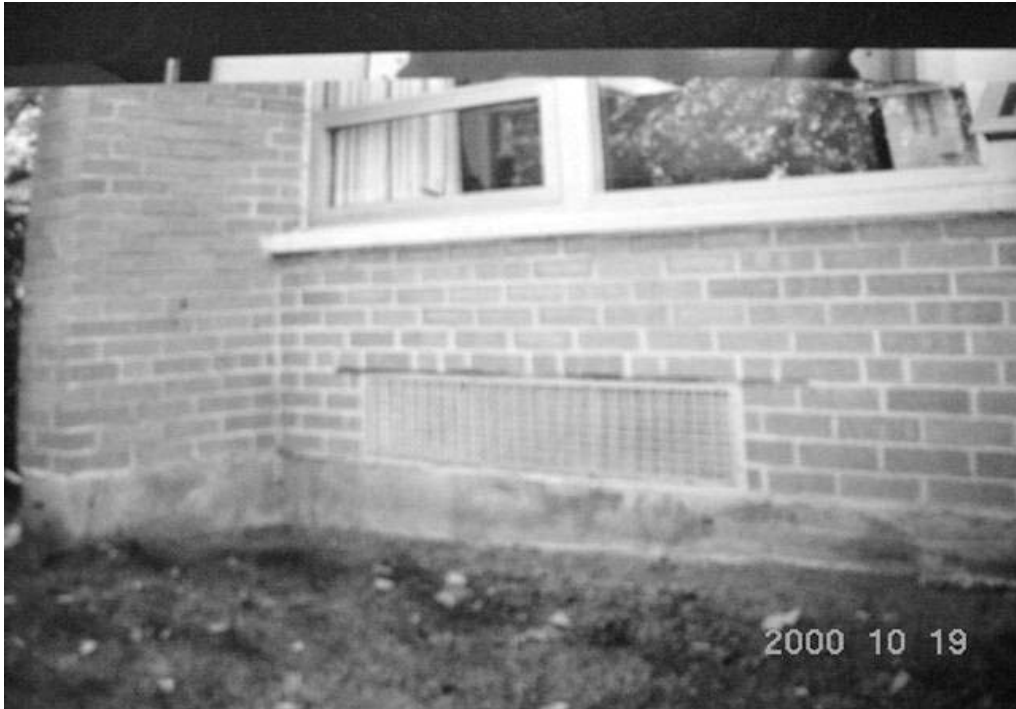
Picture 2

Univent Fresh Air Intake

3. Survey classrooms for univent function to ascertain if an adequate air supply exists for each room and make univent repairs as needed. Check fresh air intakes for repair and increase the percentage of fresh air intake if necessary.

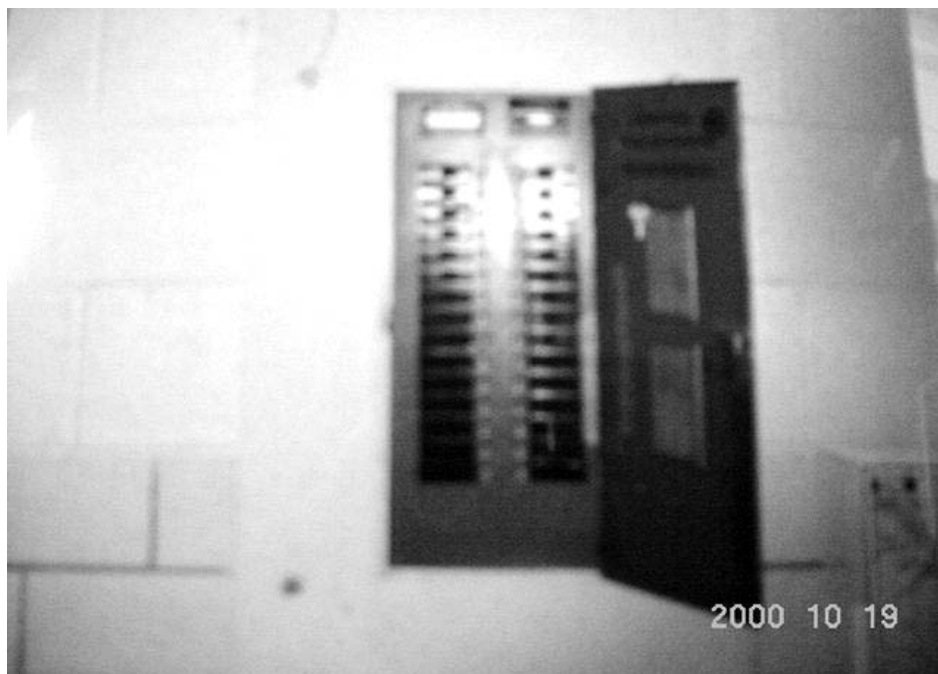
Picture 3

Hallway Electrical Panel Which Control Classroom Univents

1. Lock circuit breaker switch box controlling univents to prevent tampering.

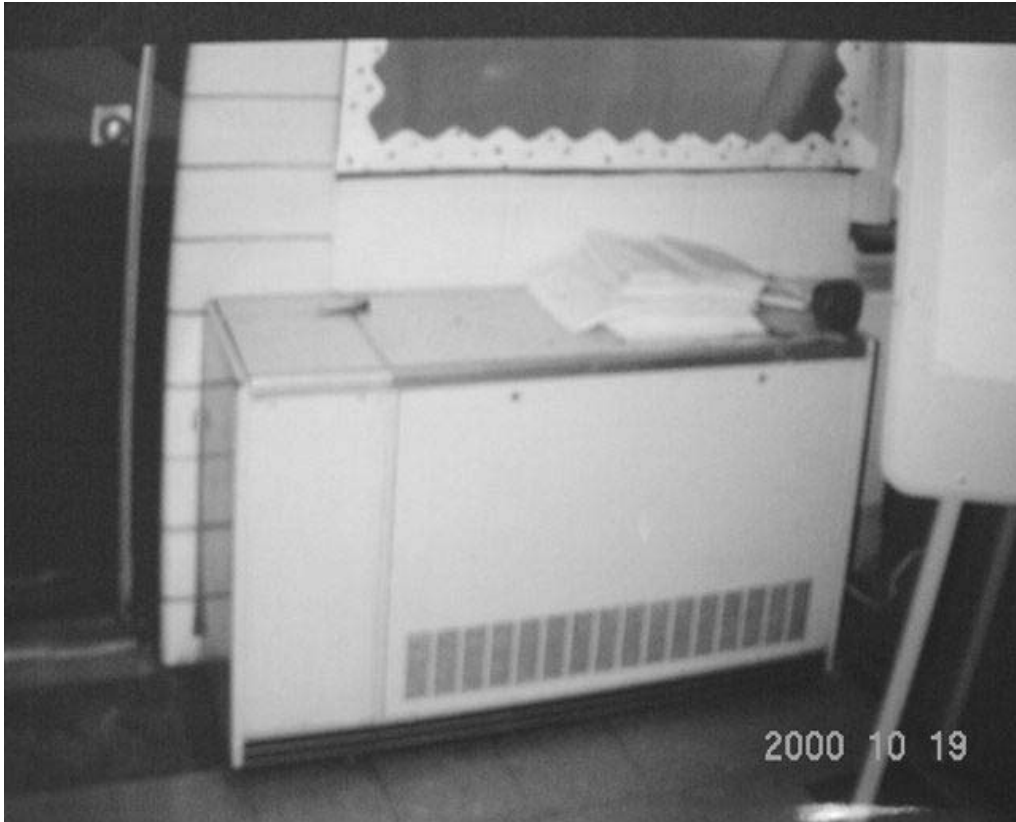
Picture 4

Two separate exhaust systems exist in the school. The exhaust ventilation is provided by unit exhaust ventilators in most areas (see Picture 4). None of these units were operating during the assessment. It was reported that exhaust ventilators had not functioned for years. A second exhaust ventilation system exists within coat closets in each classroom. This second system is a ducted system, with the return grille located in the ceiling of the coat closets (see Picture 5). Classroom air is drawn into the coat closet from the classroom via undercut closet doors (see Picture 6). These vents were designed to remove moisture/odors from the closets and do not appear to be designed to serve as the main classroom exhaust vents. This exhaust system was operational but no draw of

Classroom Unit Exhaust Ventilator

1. Contact an HVAC engineering firm to evaluate unit exhaust ventilators for function.
Examine the feasibility of repairing/replacing equipment to restore classroom exhaust ventilation.
2. Consider having an HVAC engineer calibrate univent fresh air control dampers school-wide.
3. Once both the fresh air supply and exhaust ventilation are functioning, the systems should be balanced.

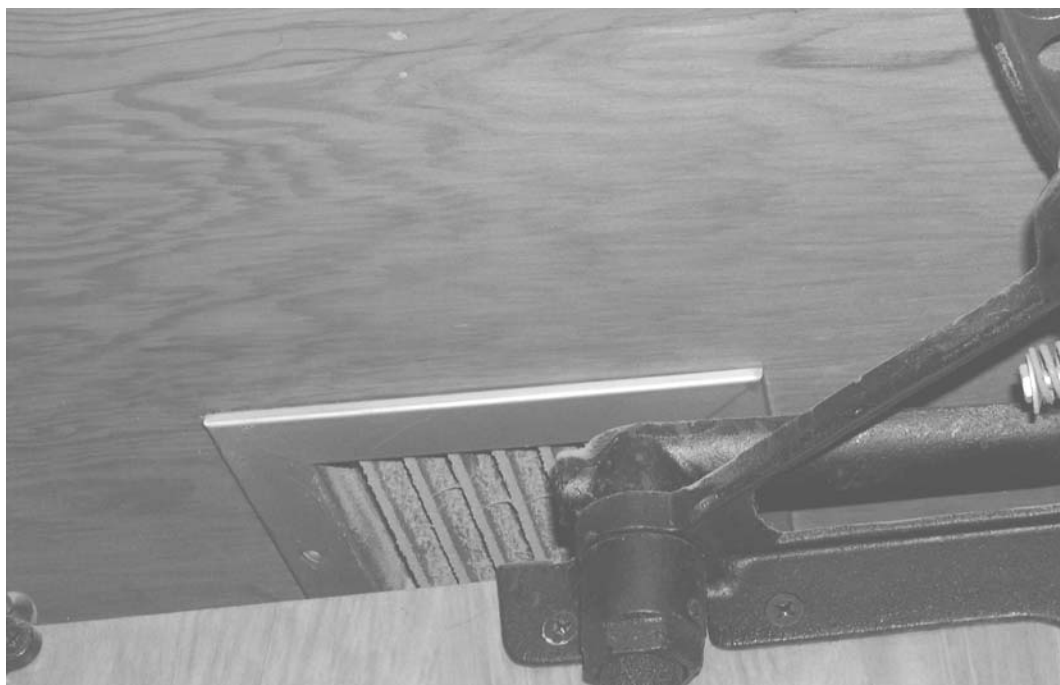
Picture 5

Exhaust Vent Located in Classroom Coat Closet

4. Ensure closet exhaust vents are activated during periods of school occupancy. Inspect exhaust motors and belts periodically for proper function. Repair and replace as necessary.

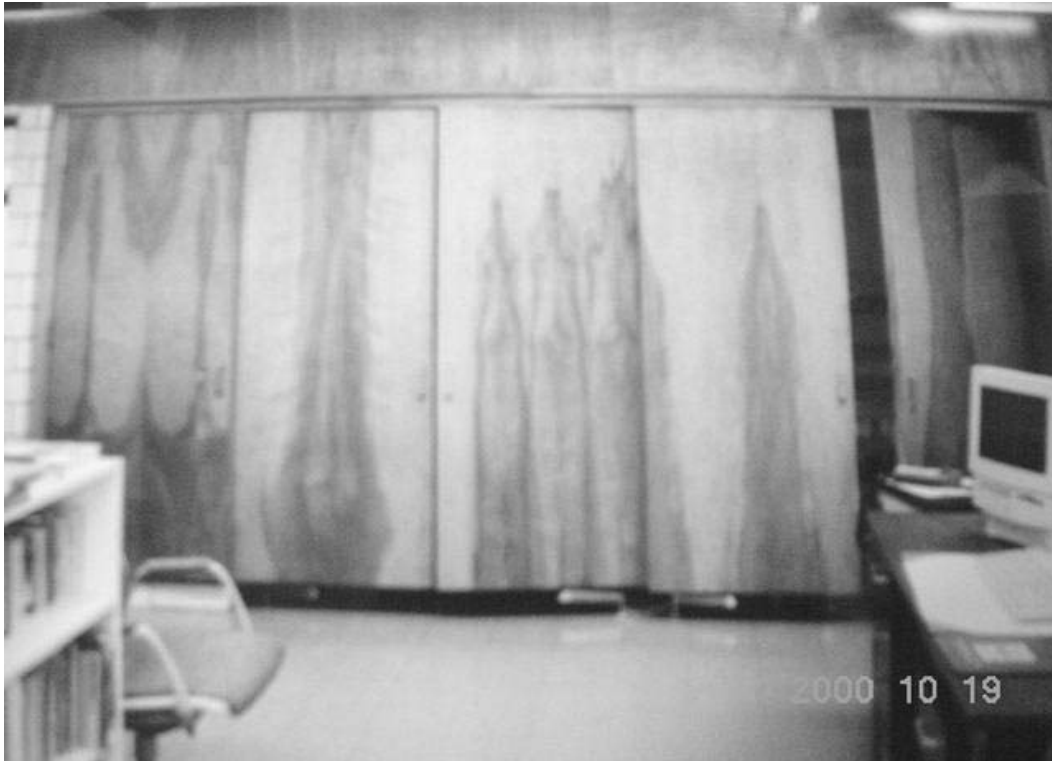
Picture 6

Closet Doors – Undercut to Allow for Exhaust Airflow

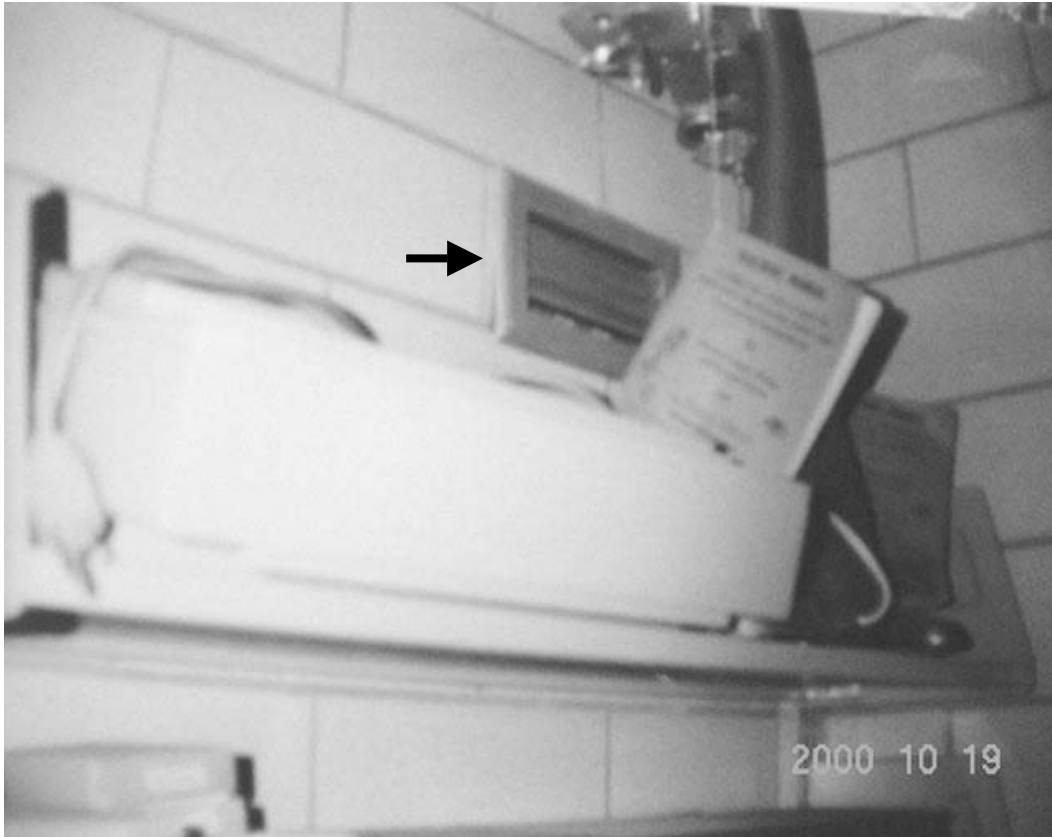
Picture 7

Exhaust Vent Located in Computer Room behind Partition

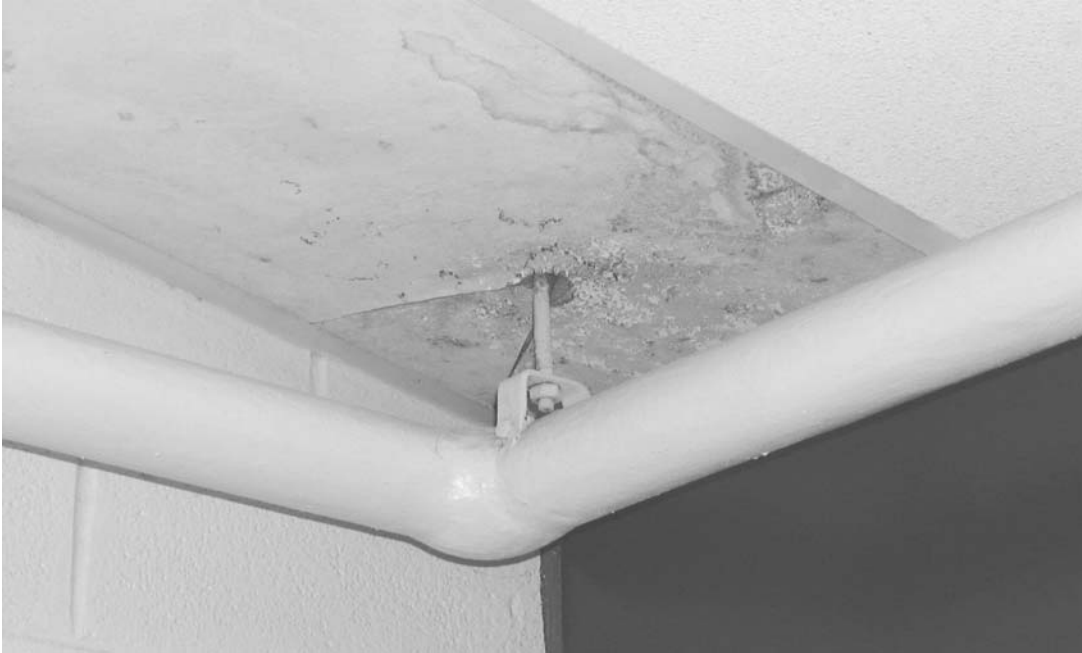
Picture 8

Several classrooms had water-stained ceiling tiles, which are evidence of historic roof or plumbing leaks (see Picture 8). Water-damaged ceiling tiles can provide a source of mold and mildew and should be replaced after a water leak is discovered and repaired. No recent water damage was reported by building occupants.

Water Damaged Ceiling Tile

7. Repair any water leaks and replace any remaining water-stained ceiling tiles. Examine the areas above these tiles for mold growth. Disinfect areas of water leaks with an appropriate antimicrobial as needed.

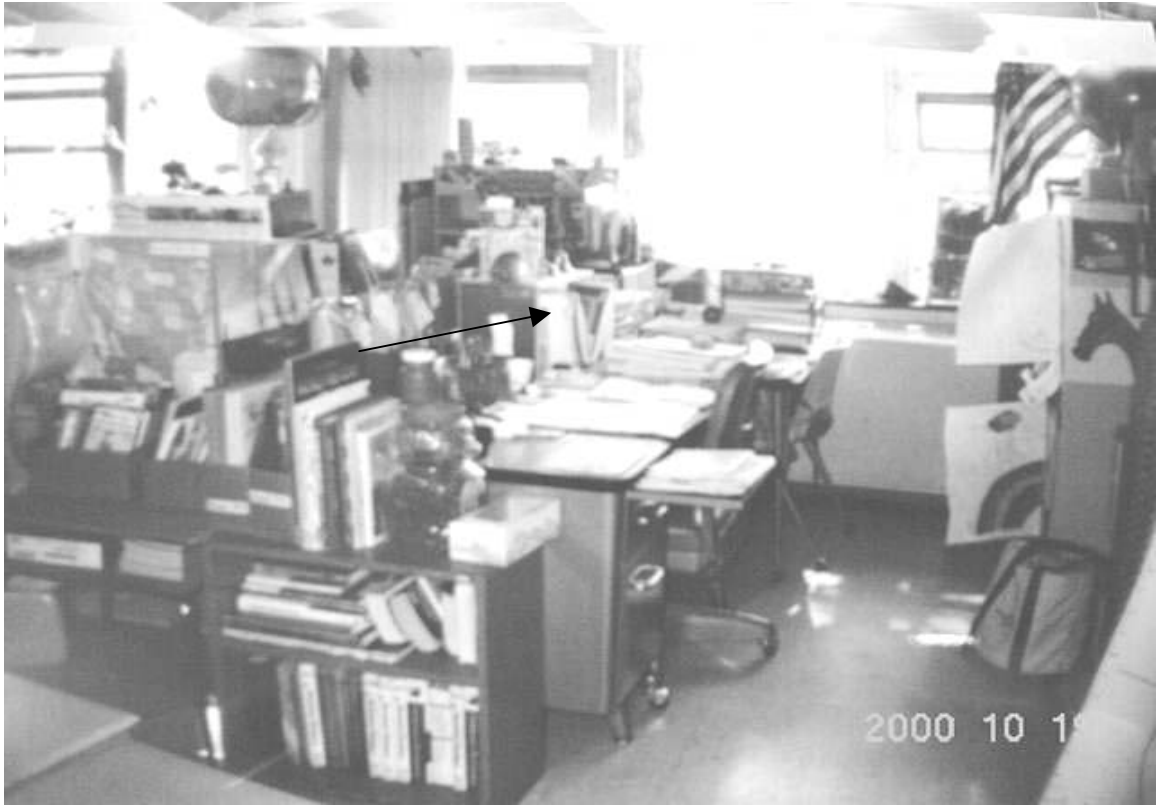
Picture 9

Also of note was the amount of materials stored inside classrooms (see Picture 10). Items were seen piled on windowsills, tabletops, counters, bookcases and desks in classrooms throughout the school. The large amount of items stored allows for dusts and dirt to accumulate. These stored items, (e.g. papers, folders, boxes) make it difficult for custodial staff to clean. Dust can be irritating to the eyes, nose and respiratory tract.

Accumulated Items in a Classroom

9. Relocate or consider reducing the amount of materials stored in classrooms to allow for more thorough cleaning. Clean items regularly with a wet cloth or sponge to prevent excessive dust build-up.

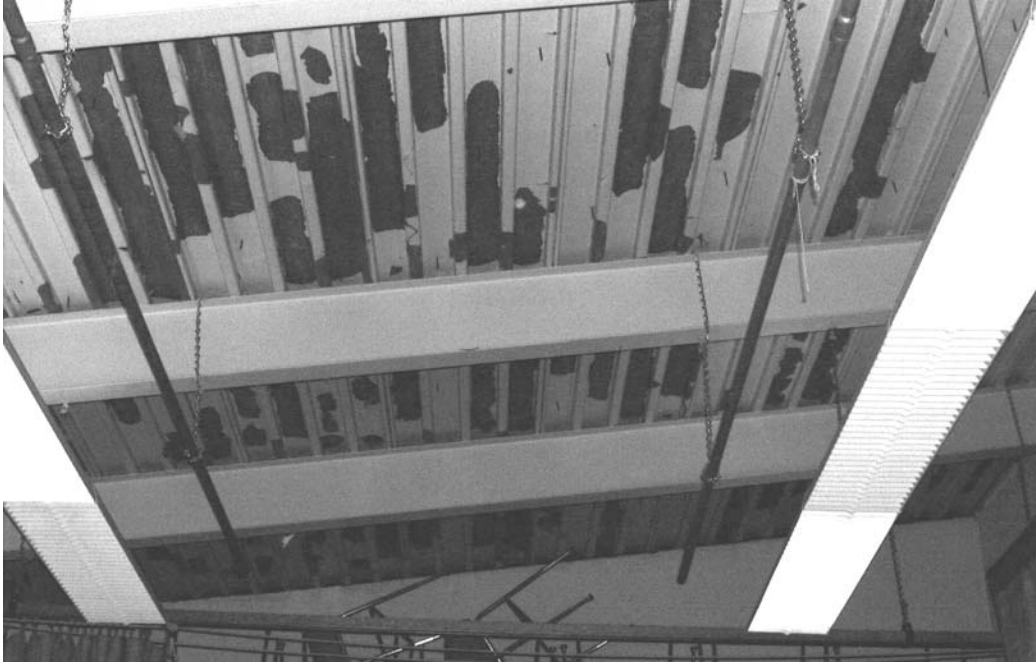
Picture 10

A number of other conditions that can potentially affect indoor air quality were also observed. The metal deck above the stage area in the cafeteria has peeling paint (see Picture 9). If this paint is a latex or related product, this peeling paint can indicate that the metal surface was not primed appropriately. Without primer, the coat of paint cannot form a seal with the metal, resulting in peeling. If this paint was applied prior to 1980, it

is possible that it may contain lead. Lead containing paint can be a hazard to small children. Lead paint is required to be removed from residences with children six years old and under. While the lead paint is not required by Massachusetts statute to be removed in non-residential buildings, prudent public health practice would be to remediate peeling lead paint, particularly if students aged six years and under have access to the stage area.

Peeling Ceiling Paint in Cafeteria Stage Area

8. Determine whether peeling paint over the stage contains lead. If paint contains lead the decking and paint coating should be evaluated by a licensed lead paint removal

contractor, and any exposure opportunities should be eliminated through removal or encapsulation.

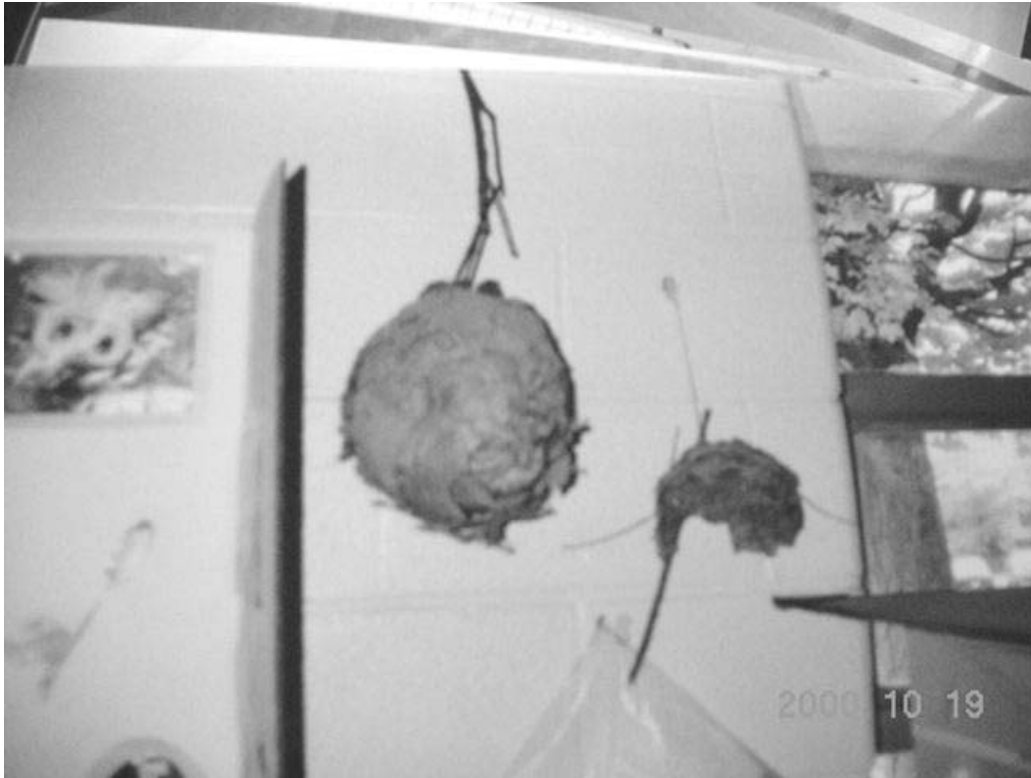
Picture 11

A number of display wasp's nests were noted in classroom 9 (see Picture 11). Insect parts can become dried out, aerosolized and may serve as a source of allergenic material for sensitive individuals. Classroom 16 had a build up of chalk dust (see Picture 12). Classroom 17 contained a pipe with damaged fiberglass insulation (see Picture 13). Chalk dust and fiberglass fibers can be sources of eye and respiratory irritation.

Inactive Wasps/Hornet's Nests in Classroom

13. Store chemicals and cleaning products properly and out of the reach of students.
14. Keep wasp's nest away from univents to prevent the aerosolization of potentially allergenic materials. Consider bringing in items on an "as needed" basis.

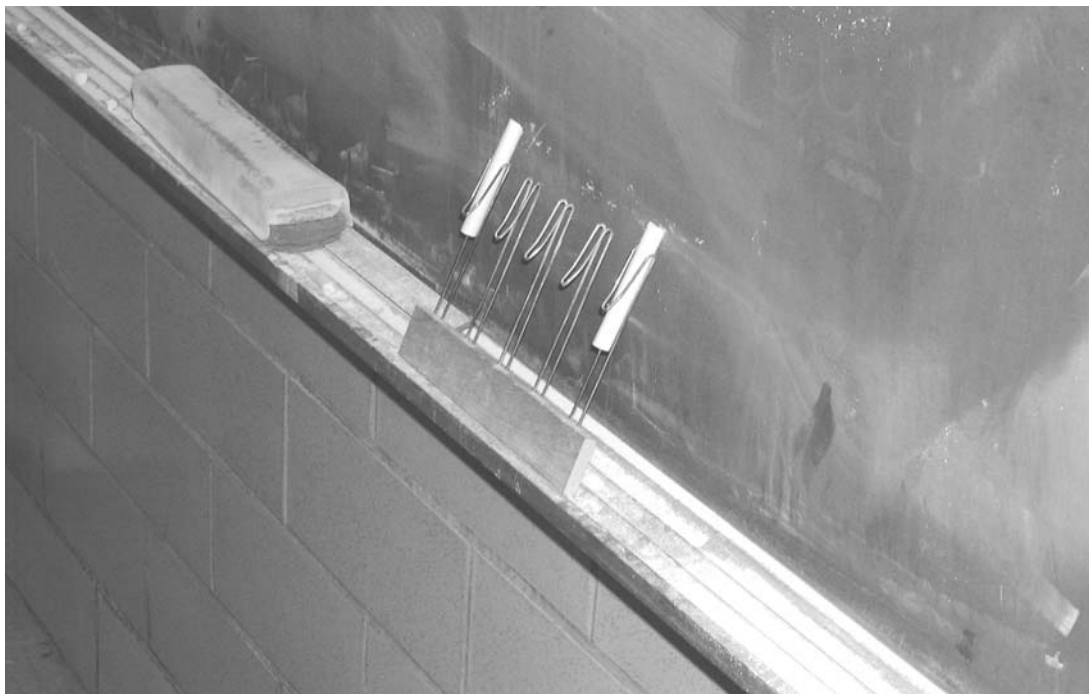
Picture 12

Accumulated Chalk Dust

15. Clean chalkboards and chalktrays regularly to prevent the build-up of excessive chalk dust.
16. Consider increasing the dust-spot efficiency of HVAC filters. Prior to any increase of filtration, each piece of air handling equipment should be evaluated by a ventilation engineer as to whether it can maintain function with more efficient filters.

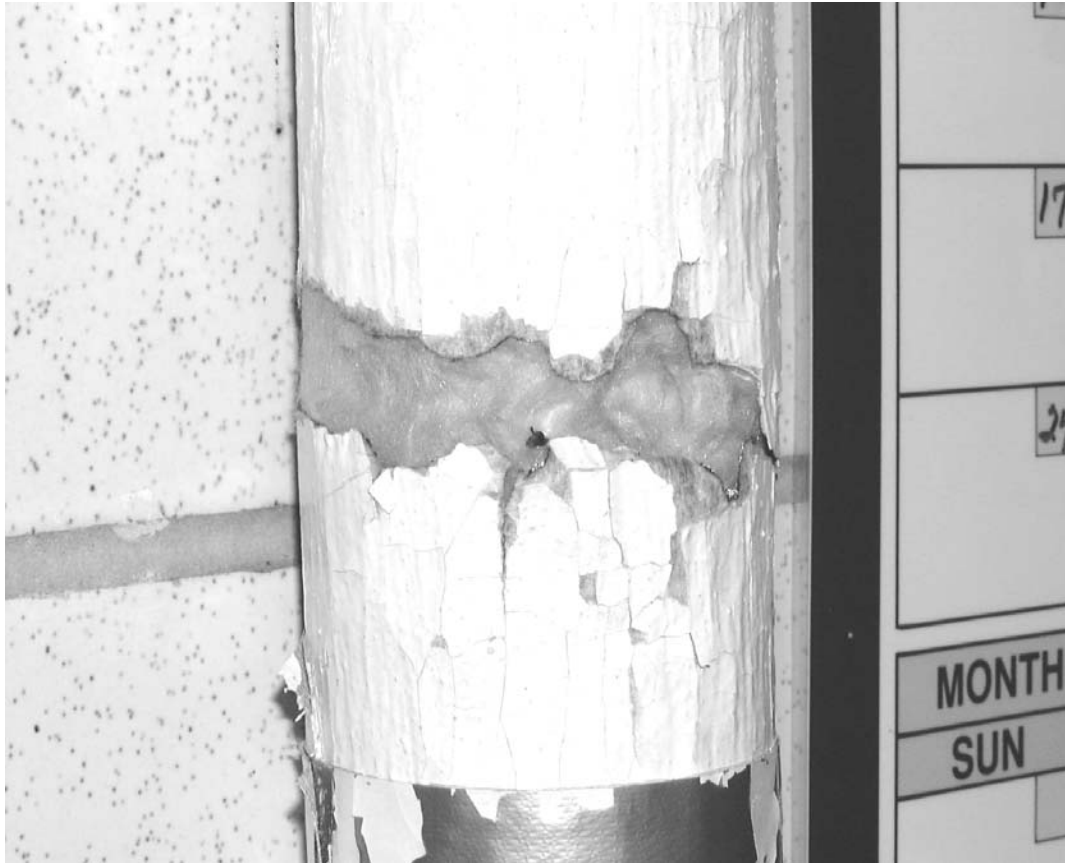
Picture 13

Damaged/Exposed Fiberglass Pipe Insulation

17. Encapsulate damaged/exposed fiberglass in classroom 17.
